Maryland Inventory of Historic Properties Historic Bridge Inventory Maryland State Highway Administration Maryland Historical Trust

Name and SHA No. M 40 over Broad Run

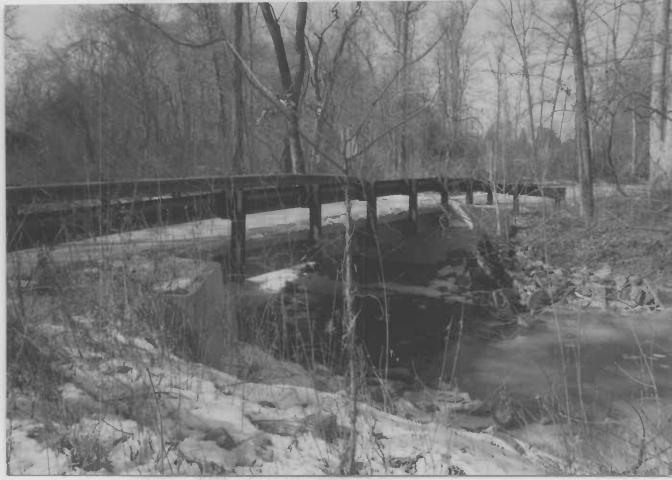
Name M40-RIVERBOOVER BROAD RUN
County/State MONTGOMERY / MD
Name of Photographer FRANK JULIANO
Date 2 45
Location of Negative SHA
Description ELEVATION SOUTH
Number 24 of 36

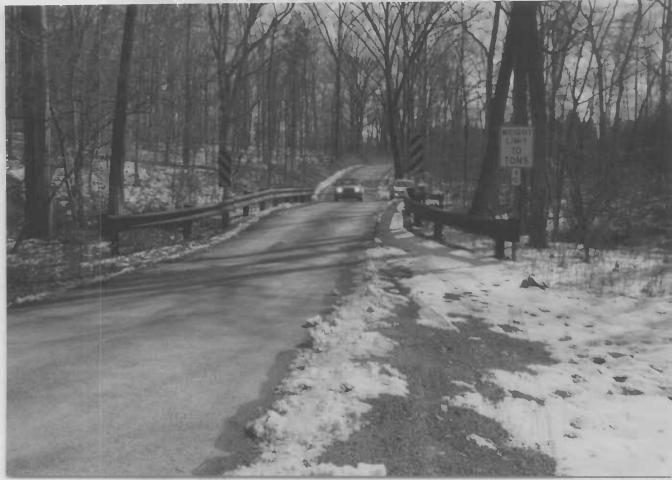
Name M40- RIVER ROOVER BROAD RUN
County/State MONTGOMERY / MD
Name of Photographer FRANK JULIANO
Date 2 95
·
Location of Negative SHR
Description Approach East
2 4
Number 35 of 36

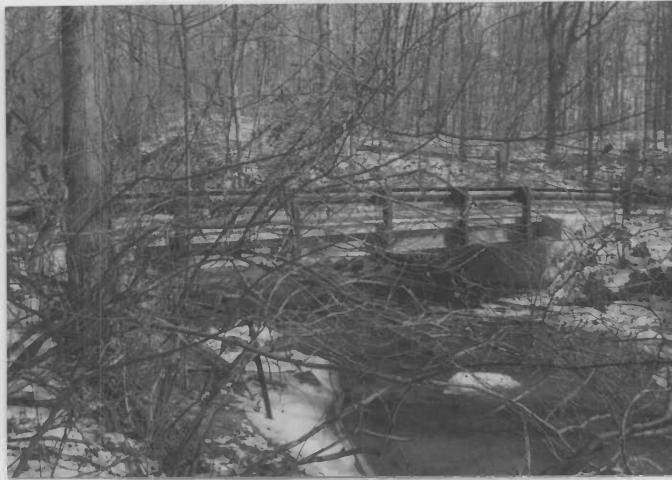
Name M40-RIVER RO OVER BROADRUN
County/State MONTGOMERY MO
Name of Photographer FRANK JULIANO
Date 2 95
Location of Negative SHA
Location of regarde
Description ELEVATION NORTH
Number 36 of 34

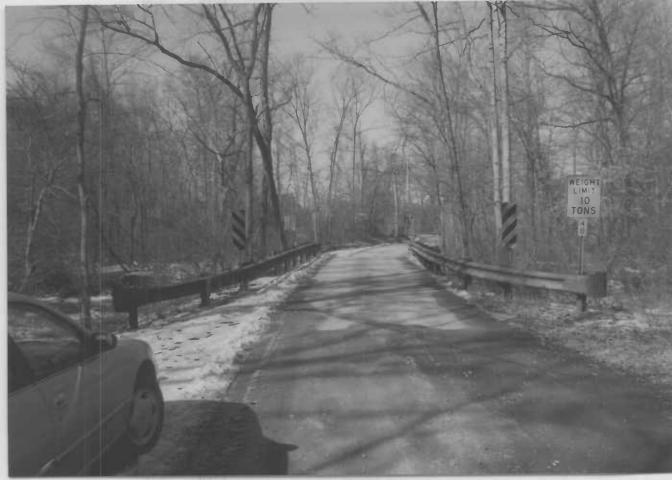
Name M40-RIVER ROOVER BROAD RUN
County/State MONTGOMERY MO
Name of Photographer FRANK JULIANO
Date 2 95
Location of Negative SHA
Description WEST APPROACH
Number <u>37 of 4</u>
